Manhole Inspection Summary

Manhole # S51CC_006MH

Insp Date: 2/21/08 11:42 AM

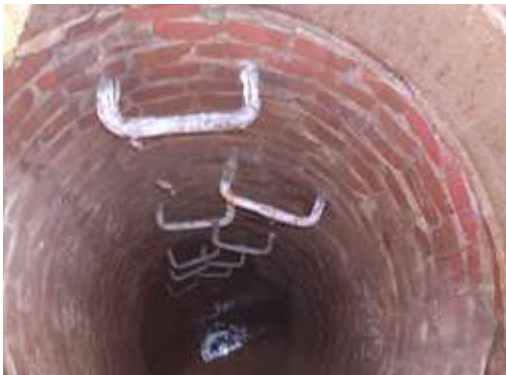
Defect 3

Frame Offset: **2** (in.) Condition: ☐ Sound ☐ Cracked ☒ **Leaks**

frame leaks

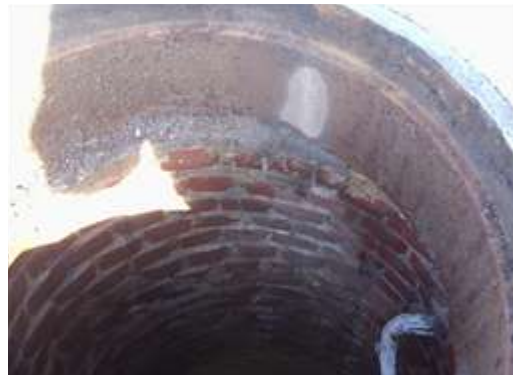
Defect 2

Chimney / Frame Adjustment ☒ Exists Material: **Brick** ☐ Parged Height: **3** (in.)

adjustment frame

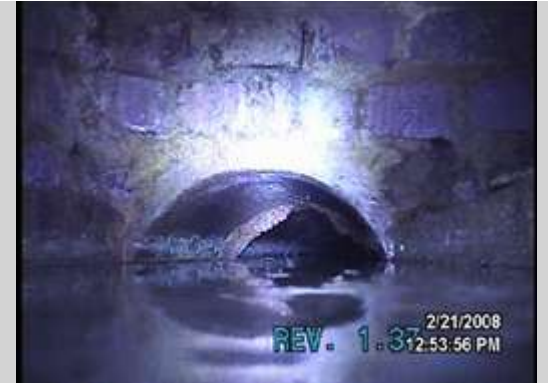
12 O'Clock Outflow

Pipe Height: **12** (in.) Rod and Bar (Angled)
Pipe Material: **Clay** ☐ Pipe Lined
Invert Depth: **17.45** (ft.) Flow Characteristics: **Slow**
Deposits: ☐ None ☒ **Mud** ☒ **Sludge** ☐ Debris ☐ Grease
Silt Depth: **6** (in.) Deposits Extent: **Heavy**
Infiltration: **None** Pipe Seal Cond: **Sound**

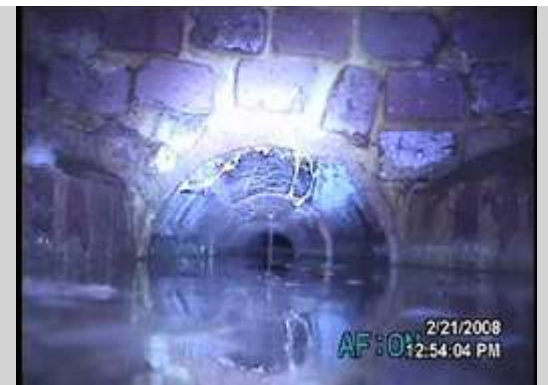
6 O'Clock Inflow

Pipe Height: **12** (in.) Rod and Bar (Angled)
Pipe Material: **Clay** ☐ Pipe Lined
Invert Depth: **17.10** (ft.) Flow Characteristics: **Slow**
Deposits: ☐ None ☒ **Mud** ☒ **Sludge** ☐ Debris ☐ Grease
Silt Depth: **6** (in.) Deposits Extent: **Heavy**
Infiltration: **None** Pipe Seal Cond: **Sound**
